# Gannawarra Shire Council

## Drainage Asset Management Plan Final Report

February 2011

**Halcrow Pacific Pty Ltd**

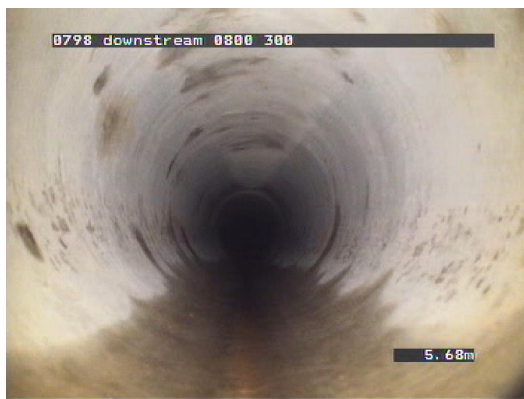
**Figure 2-7 - Good pipe condition. Condition rating 1 to 2 (Pipe 0798-0800).**

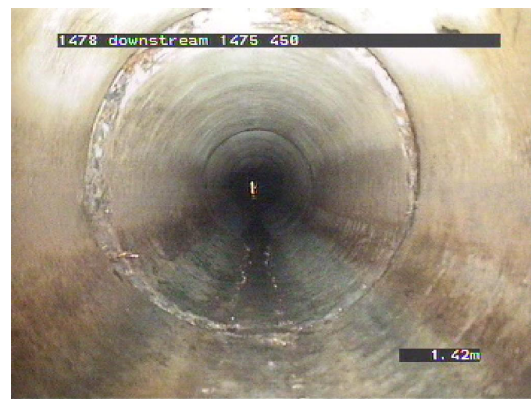
**Figure 2-9 - Minor spalling concrete at joint. Condition rating 3 to 4 (Pipe 1478-1475).**

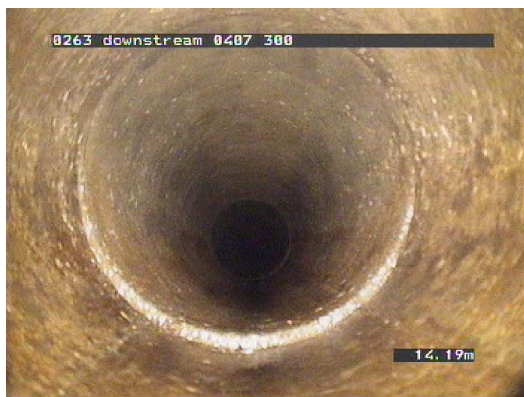
**Figure 2-8 - Minor joint displacement. Condition rating 3 to 4 (Pipe 0263-0407).**

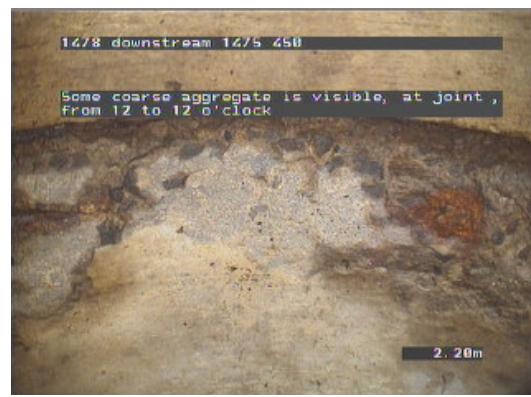
**Figure 2-10 - Close view of spalling defect in Figure 2-9.**

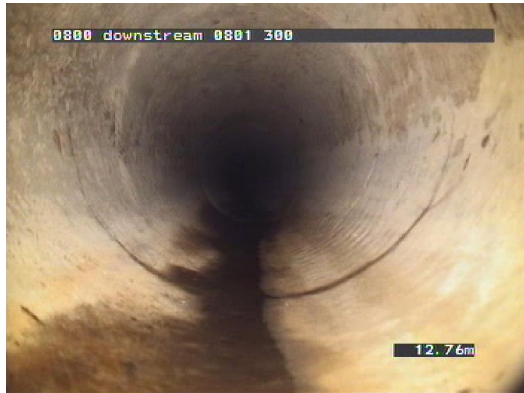
Figure 2-11 - Circumferential crack from 3 to 9 o'clock Condition rating 5-6 (Pipe 0800-0801).

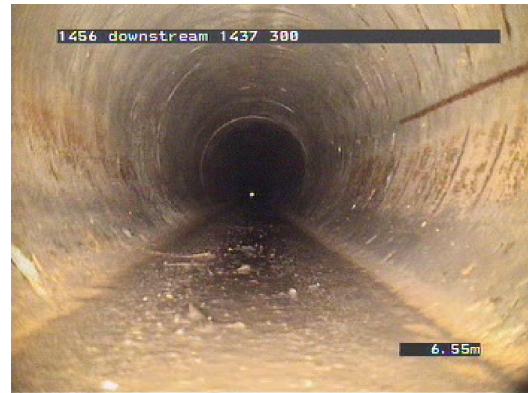
Figure 2-13 - Exposed circumferential and longitudinal reinforcement. Also note sediment build-up. Conditions rating 7 to 8 (Pipe 1456-1437).

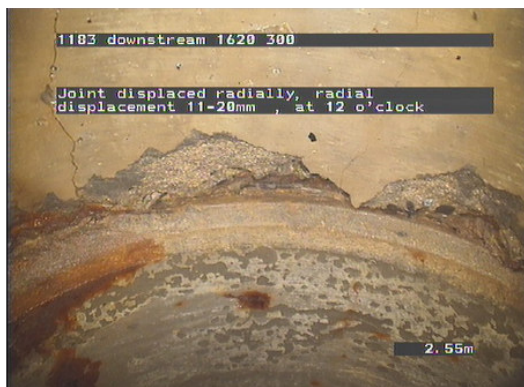
Figure 2-12 - Greater joint displacement, spalling concrete and cracking. Condition rating 7-8 (Pipe 1183-1620).

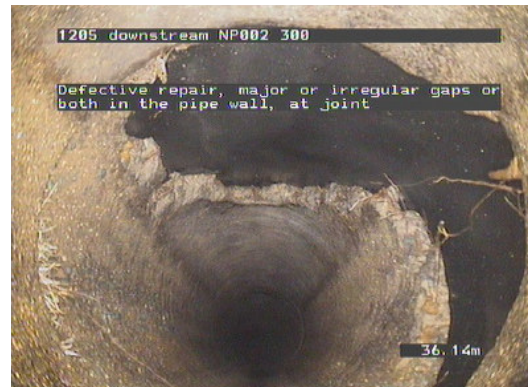
A number of structural failures (rating 9 or 10) were found in some sections of drainage pipe due to major circumferential cracking or large, defective repairs. The circumferential cracking is likely caused by pipe movement due to movement of the soil or pipe bedding, or differential movement between the pipe and pit in close proximity to the pit. The need for large repairs on the drains is not known for certain, however damage during installation or subsequent excavation works could be the cause. Replacement of the damaged pipe segments would have been more appropriate given the size and nature of the repair. Table 2-3 below lists where the assessed structural failures were observed.

Figure 2-14 - Large, defective structural repair. Condition rating 9-10 (Pipe NL002).

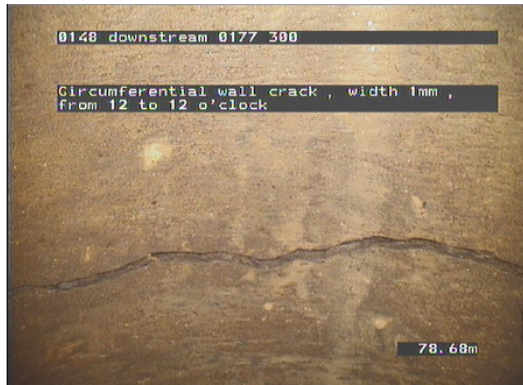
Figure 2-15 - Complete circumferential cracking. Condition rating 9-10 (Pipe 0148-0177).

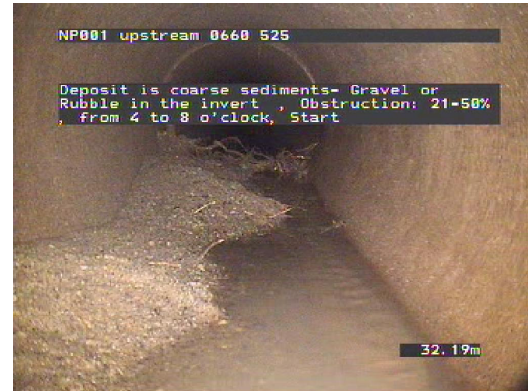
Notwithstanding the above, heavy root penetration and/or sedimentation was observed in a number of the drains reviewed to the extent that blockage and significant reduction in hydraulic capacity is likely.

Figure 2-17 - Example of sedimentation and (in background root penetration).

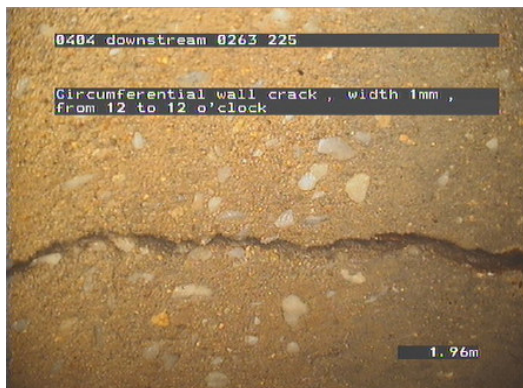
Figure 2-16 - Complete circumferential cracking. Condition rating 9-10 (Pipe 0404-0263)
