# Gannawarra Shire Council

## Drainage Asset Management Plan Final Report

February 2011

**Halcrow Pacific Pty Ltd**

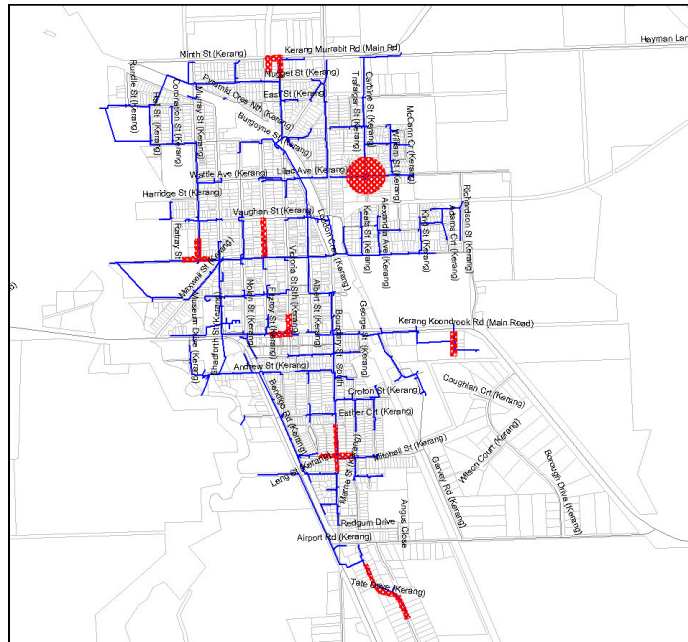
Figure 1-5 - Kerang drainage ‘hot spots’

The known hot spots in Kerang and Koondrook identified by Council are shown in Figure 1-5 and Figure 1-6 respectively and are hatched red. The drainage system in Quambatook has also been identified by Council as a general hot spot. Further discussion about how the hot spot areas can be addressed is contained in Section 4.3.5.

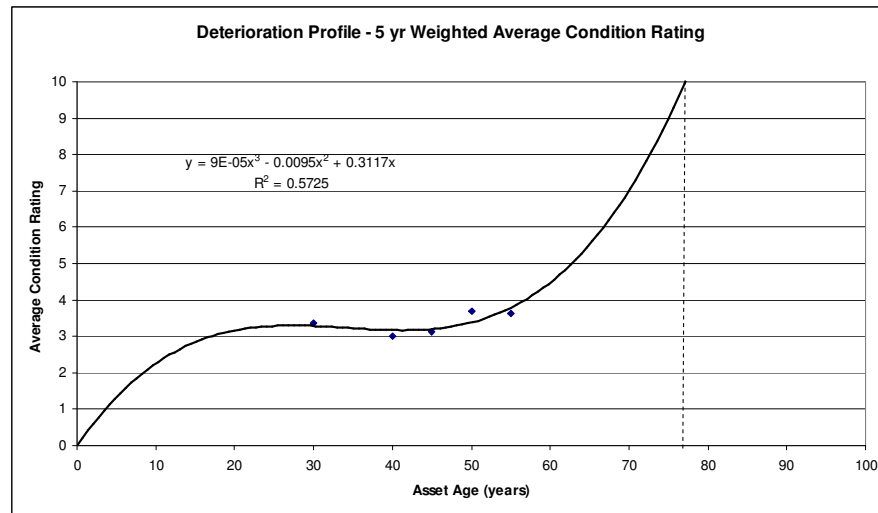
**Figure 3-1 - Drainage Deterioration Profile for Gannawarra Shire Council  
(based on 5 year groupings)**

The results show that a third order polynomial was the best fit to the data. This is due to the relatively small variation in pipe age and the comparatively high structural condition rating of the younger pipes. Some pipes in the 25 to 30 year showed significant structural deterioration.

These concrete pipes could in theory last for hundreds of years, however once structural defects, due to whatever reason, reach a moderate level they often experience accelerated failure and are no longer serviceable. For example, an average pipe will have an average condition rating of 6 after approximately 105 years, however will generally experience rapid deterioration after this time, to reach the end of its life at an average of 125 years.

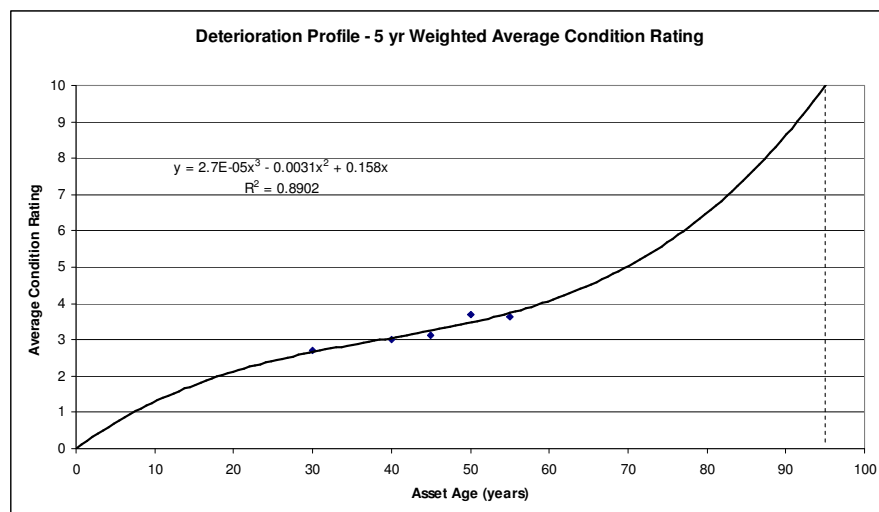
**Figure 3-2 - Revised Drainage Deterioration Profile for Gannawarra Shire Council (based on 5 year groupings)**

Rather than remove these five selected drains from the review sample (and risk making the sample size smaller), the condition rating was modified (i.e. improved). This corrected the profile curve that raised the average asset life to approximately 94 years. Refer to Figure 3-2. This was approach was taken based on Halcrow’s knowledge and experience of drainage condition assessment and drainage asset management. In other similar studies completed, the average service life of a pipe asset (across all sizes and material types) was found to range from about 125 to 180 years. Pipe manufacturers often claim a 100 design life for their products.

It should be noted that on average 50% of the assets will have failed prior to 94 years old.

The revised profile curve is more consistent with expectations and makes a balanced allowance for reduced asset life due to aggressive environmental conditions (i.e. salinity and high groundwater table, and expansive soils).
